ENVIRONMENTAL MONITOR WEEKLY REPORT
WEEK ENDING **July 14, 2017**

INSPECTIONS

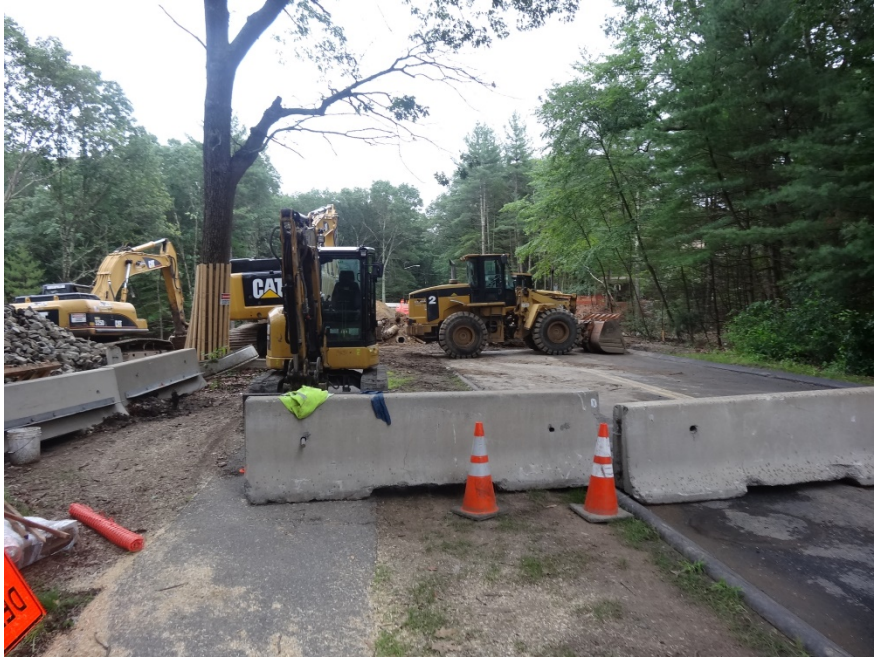
WORK AT POWDER MILL ROAD HAS BEGUN

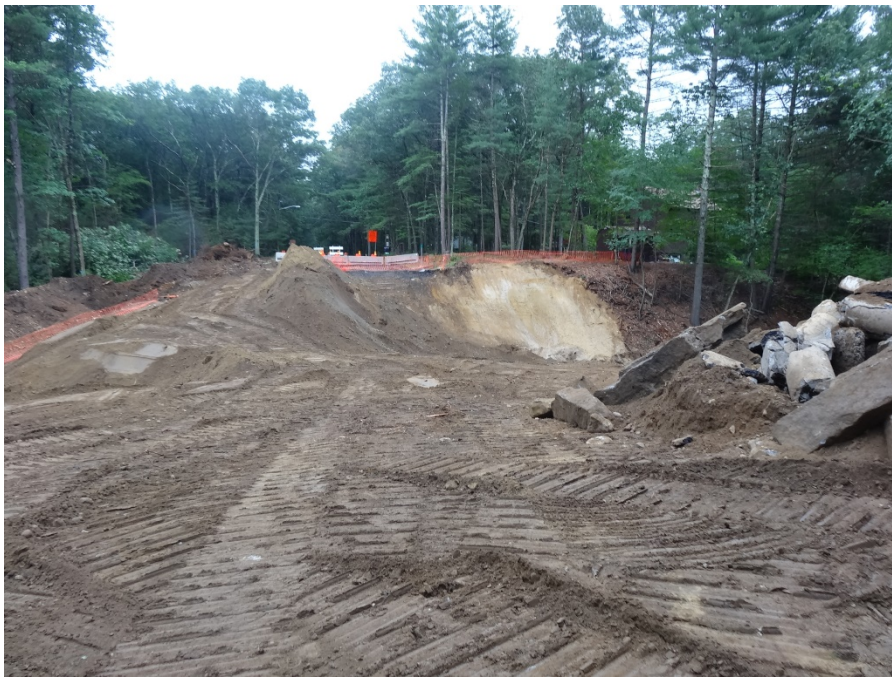
FULL DEPTH EXCAVATION IS NEEDED TO INSTALL NEW CULVERT

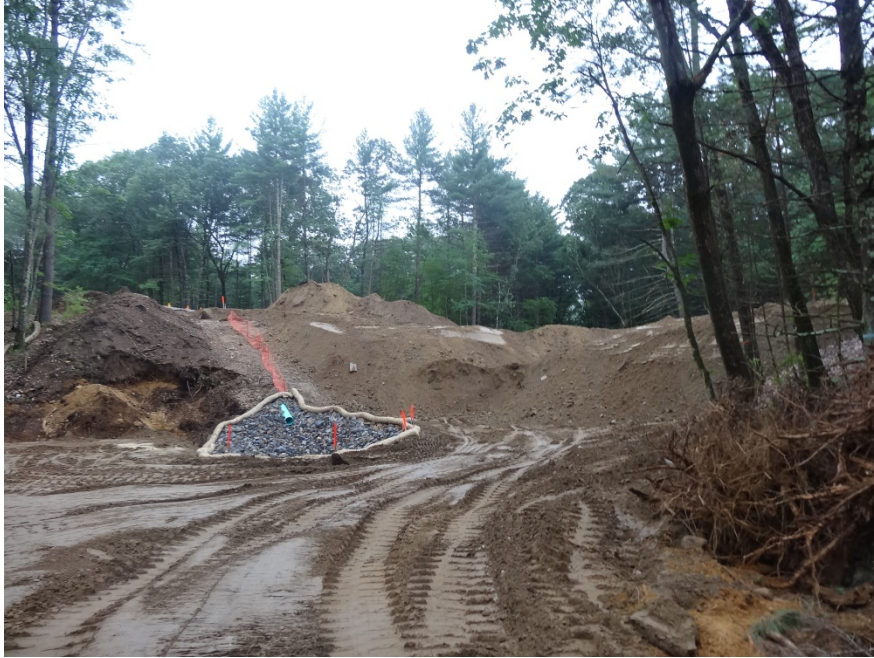
TEMPORARY DRAINAGE INSTALLATION HAS BEGUN.

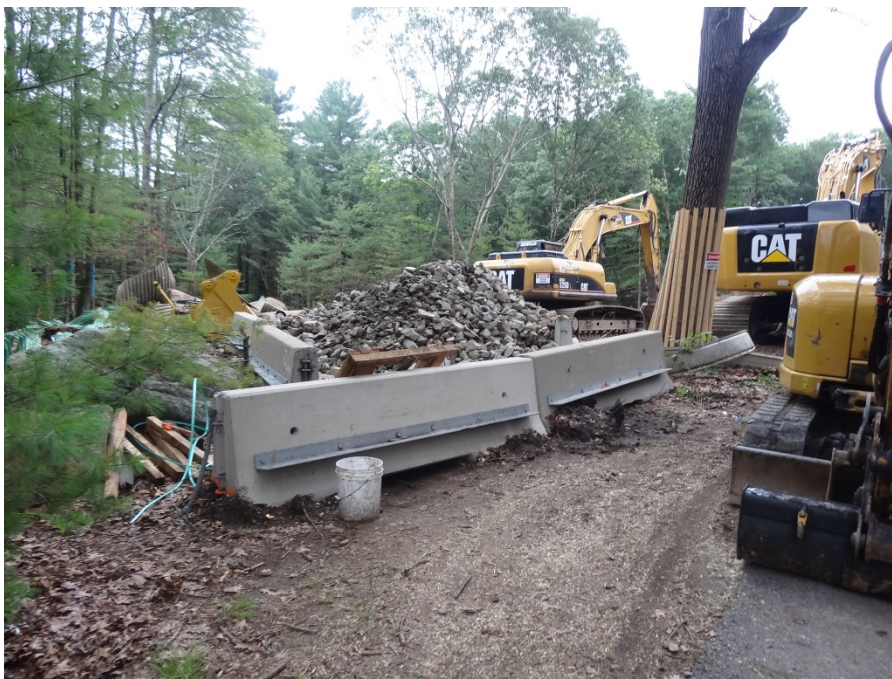
STOCKPILED MATERIALS & EQUIPMENT OUTSIDE OF REGULATED AREAS
